Energy Procedia 96 (2016) 601 – 612

SBE16 Tallinn and Helsinki Conference; Build Green and Renovate Deep, 5-7 October 2016,  
Tallinn and Helsinki

## Evaluation of the thermal environment for condensation and mold problem diagnosis around built-in furniture in Korean apartment buildings during summer and winter

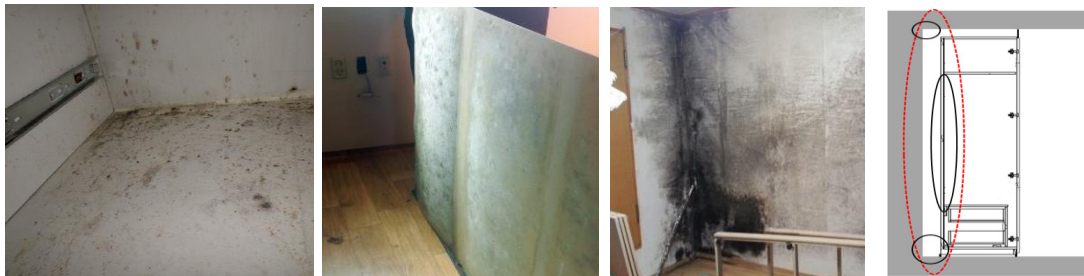
Fig. 1 (a) (b) (c) Condensation and mold problems around the built-in furniture; (d) schematic of cross-section of built-in furniture

As demonstrated in Fig. 1, the areas around the built-in furniture where condensation and mold usually grow up were confirmed to be the air space between the back panels of the built-in furniture and the building structure, as demonstrated by the condensation and mold damage cases in Korean multifamily buildings. It is necessary to consider both the influence of condensation caused by the temperature difference between the interior and exterior due to the drop of surface temperature of a building and the influence of excessive humidity generated in the interior from a lack of ventilation. As shown in Fig. 1(d), it may be more precise to measure the temperature and relative humidity of the air space existing between the back panels of the built-in furniture and the wall of the building structure. However, considering potential damages that may be caused to the back panels of the built-in furniture, which in turn, may alter the structure stability and cause damage to the property of the occupants residing in the subject apartments, the above-mentioned area was not measured. Instead, it was determined that it would be possible to predict the thermal environment of the air space between the back panels of the built-in furniture and the wall of the building structure through the interior thermal environment of the built-in furniture.

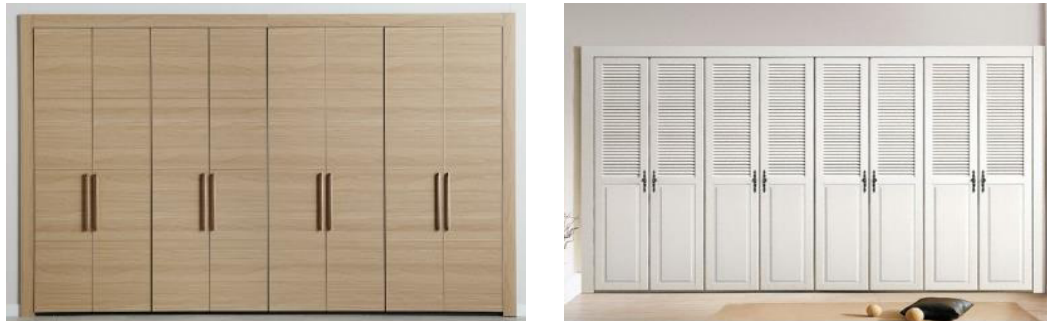
Fig. 2. a) General door type of built-in furniture (except Apartment L); b) gallery door type of built-in furniture (Apartment L).

Apartment L is located on the ground floor and the doors of the built-in furniture were a gallery door type. The rest of the apartments were located on typical floors and the doors of the built-in furniture were a general door type (Fig. 2).
